Manhole Inspection Summary

Manhole # S19E1_009MH

Location Address: **ATLANTIC AVE** Cross Street: **CSX RAILROAD**

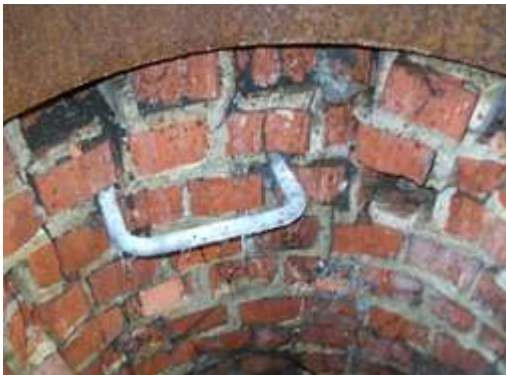
Miscellaneous

ROOT INTRUSION AT FRAME/CORBEL JOINT AND CORBEL WALL

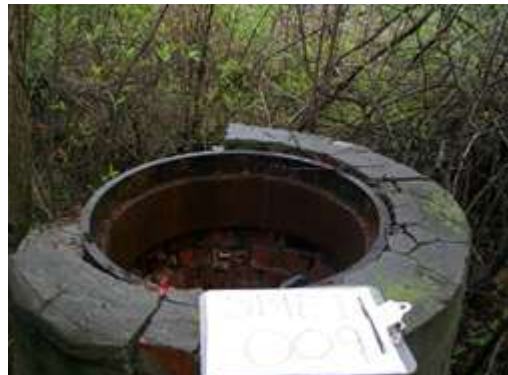
Miscellaneous

12in ABOVE GRADE

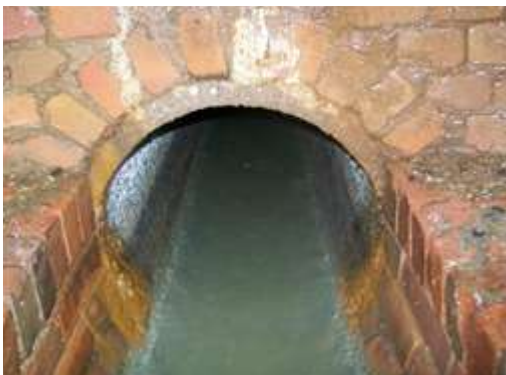
Defect 5

STAINING ON WALL INDICATES EVIDENCE OF INFILTRATION IN BARREL WALL

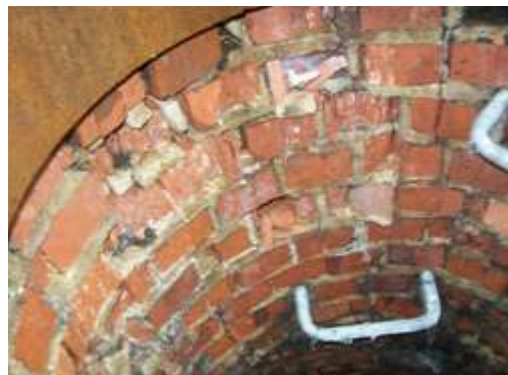
Defect 4

Corbel Material: **Brick** ☐ Parged Type: **Concentric/Eccentric**
Condition: ☐ Sound ☒ Cracked ☒ Root Intrusion ☒ Loose Brick ☒ Deteriorated
Infiltration: ☒ None ☐ Joint ☐ Cracks ☐ Mortar ☐ Roots ☐ Wall

LOOSE AND CRACKED BRICKS IN DETERIORATED CORBEL WALL

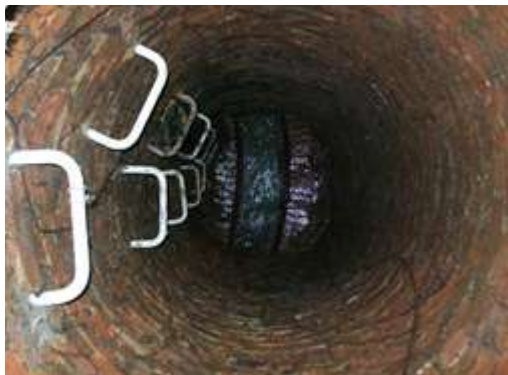
Defect 2

ROOT INTRUSION IN CORBEL WALL

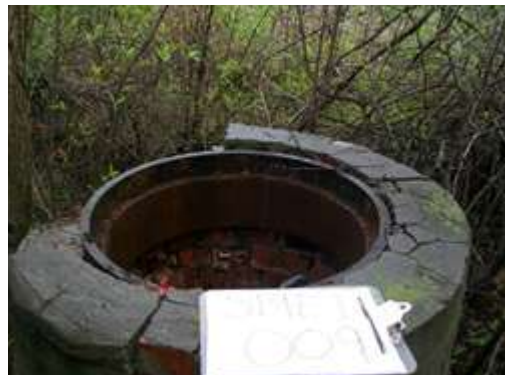
Defect 1

OUTTER CHIMNEY CRACKED AND
DETERIORATED

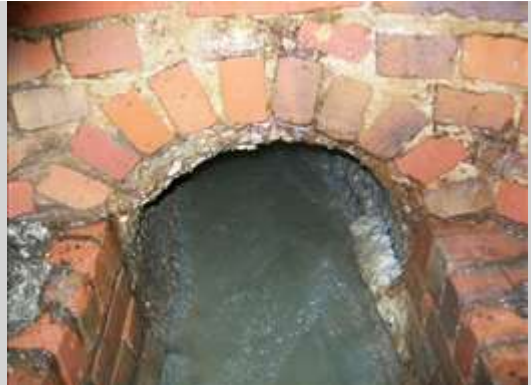
12 O'Clock Outflow

2" GREASE ON SIDE OF PIPE
CONNECTION

Deposits: ☐ None ☐ Mud ☐ Sludge ☐ Debris ☒ Grease

Silt Depth: **2** (in.) Deposits Extent: **Light**
